# Vortex Generator Flight Tests — Stall Effects

by David F. Rogers

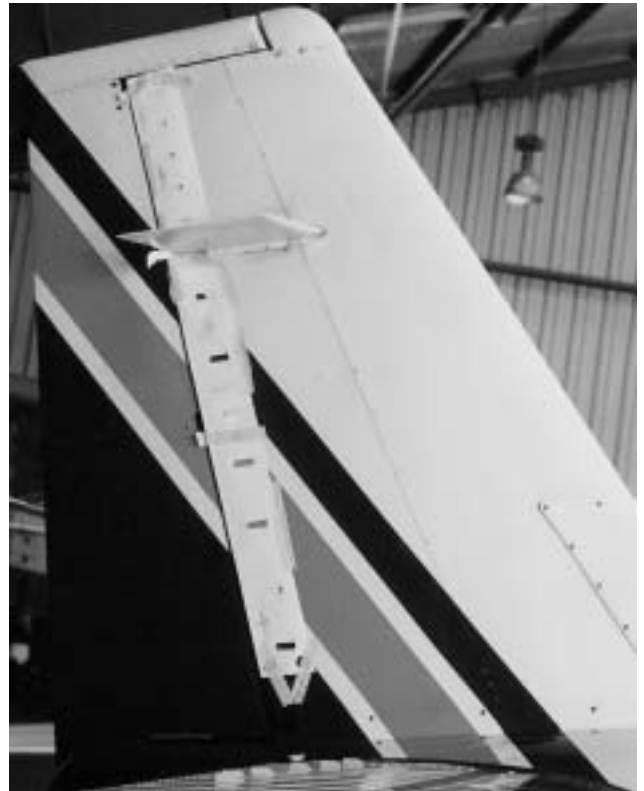
Figure 2. Vertical tail installation templates. VGs layed out on the horizontal tail for installation on the vertical tail.

instructions are very clear and detailed. Detailed templates are provided to precisely locate the VGs on both the wing and the vertical tail (shown in Figure 2). Complete installation was accomplished in approximately eight hours. The installed VGs are shown in Figures 3 and 4. An optional 100 lb. gross weight increase is available. However, the STC for the gross weight increase changes the aircraft from utility category (4.4 gs) to normal category (3.8 gs) when operating at the increased gross weight.

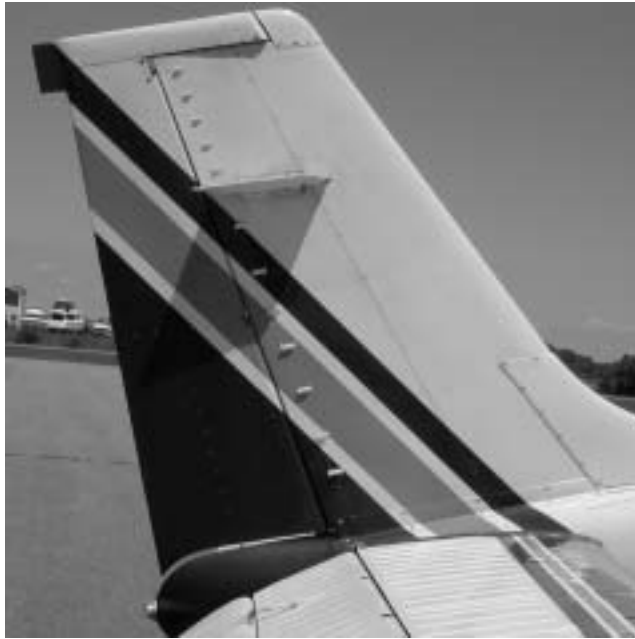
Figure 3. Vortex generators installed on vertical tail.

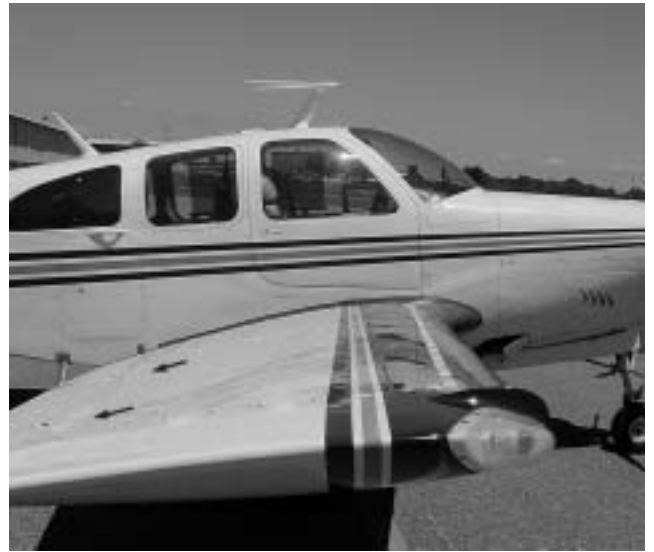
Figure 4. Vortex generators installed on wing.

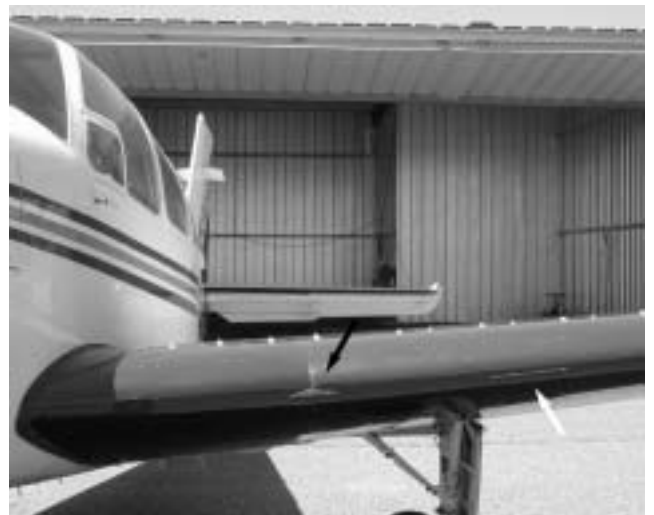
mounted on the inboard section of the wing (see Figure 5). The inboard stall/spin strip (black arrow), mounted at the crank of the wing, activates at a higher angle of attack than the outboard six inch long stall/spin strip that looks like a small piece of angle iron (white arrow).

Figure 5. Stall/spin strips.

As the aircraft is pitched up the airflow comes from underneath the outboard stall/spin strip. If the airflow comes from underneath the sharp edge of the stall/spin strip, the local airflow immediately behind the stall/spin strip separates from the wing and flows aft in a narrow turbulent stream. Because, as shown in Figure 5, the elevator balance horn is located immediately behind the small outboard stall/spin strip, the narrow stream of separated turbulent air impinges on the horn and shakes the elevator and hence the control yoke — in effect it acts as an aerodynamic stick shaker.

As the aircraft continues to pitch up at a moderate rate, the inboard stall/spin strip located at the crank of the wing activates. Here a stronger locally separated turbulent flow is generated which, as Figure 5 indicates, impinges on the center of the elevator and literally shakes the entire aircraft with
