Vortex Generator Flight Tests — Stall Effects

by David F. Rogers

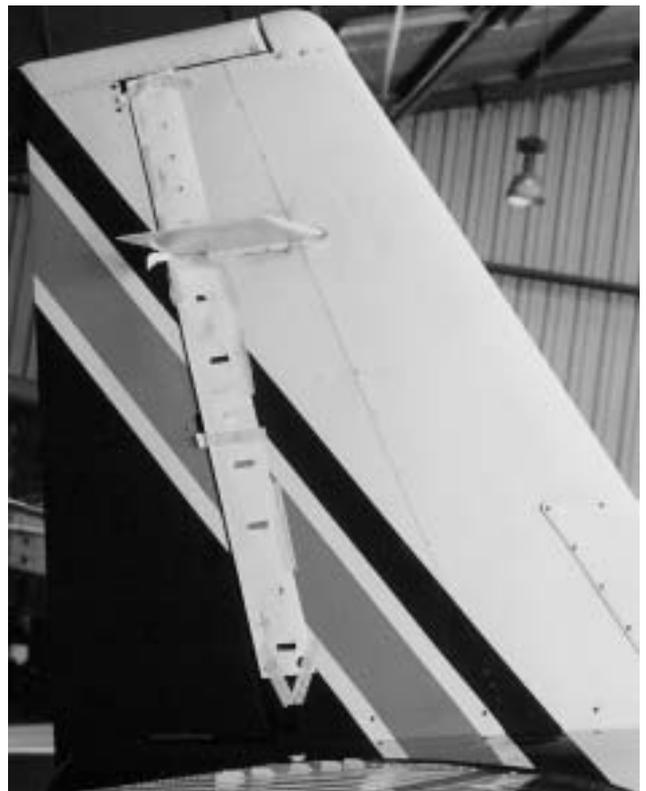
Figure 2. Vertical tail installation templates. VGs layed out on the horizontal tail for installation on the vertical tail.

instructions are very clear and detailed. Detailed templates are provided to precisely locate the VGs on both the wing and the vertical tail (shown in Figure 2). Complete installation was accomplished in approximately eight hours. The installed VGs are shown in Figures 3 and 4. An optional 100 lb. gross weight increase is available. However, the STC for the gross weight increase changes the aircraft from utility category (4.4 gs) to normal category (3.8 gs) when operating at the increased gross weight.

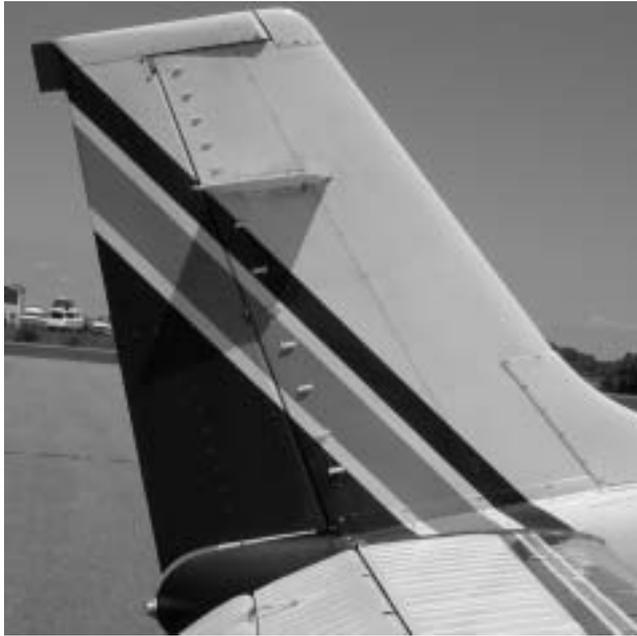
Figure 3. Vortex generators installed on vertical tail.

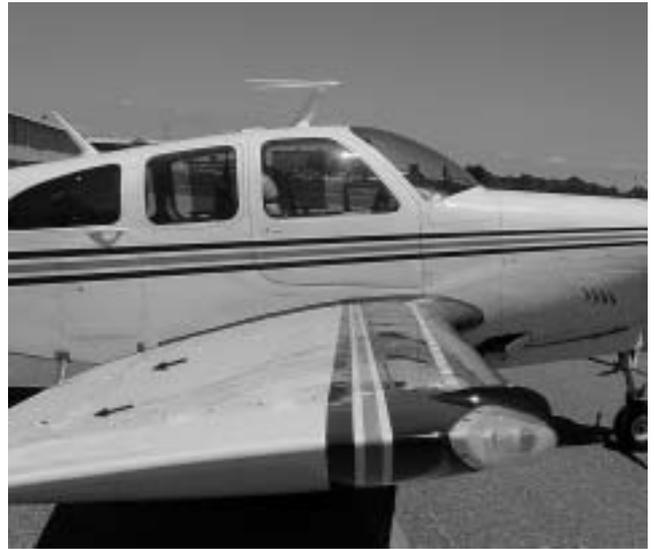
Figure 4. Vortex generators installed on wing.

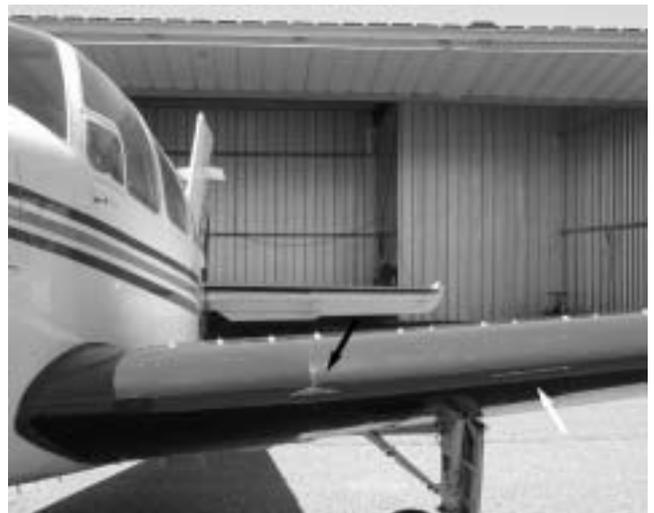
Figure 5. Stall/spin strips.

mounted on the inboard section of the wing (see Figure 5). The inboard stall/spin strip (black arrow), mounted at the crank of the wing, activates at a higher angle of attack than the outboard six inch long stall/spin strip that looks like a small piece of angle iron (white arrow).

As the aircraft continues to pitch up at a moderate rate, the inboard stall/spin strip located at the crank of the wing activates. Here a stronger locally separated turbulent flow is generated which, as Figure 5 indicates, impinges on the center of the elevator and literally shakes the entire aircraft with
