# Base to Final Stall-Spin

David F. Rogers, Phd, ATP

The base-to-final stall-spin is frequently unrecoverable. It has much to do with angle of attack.

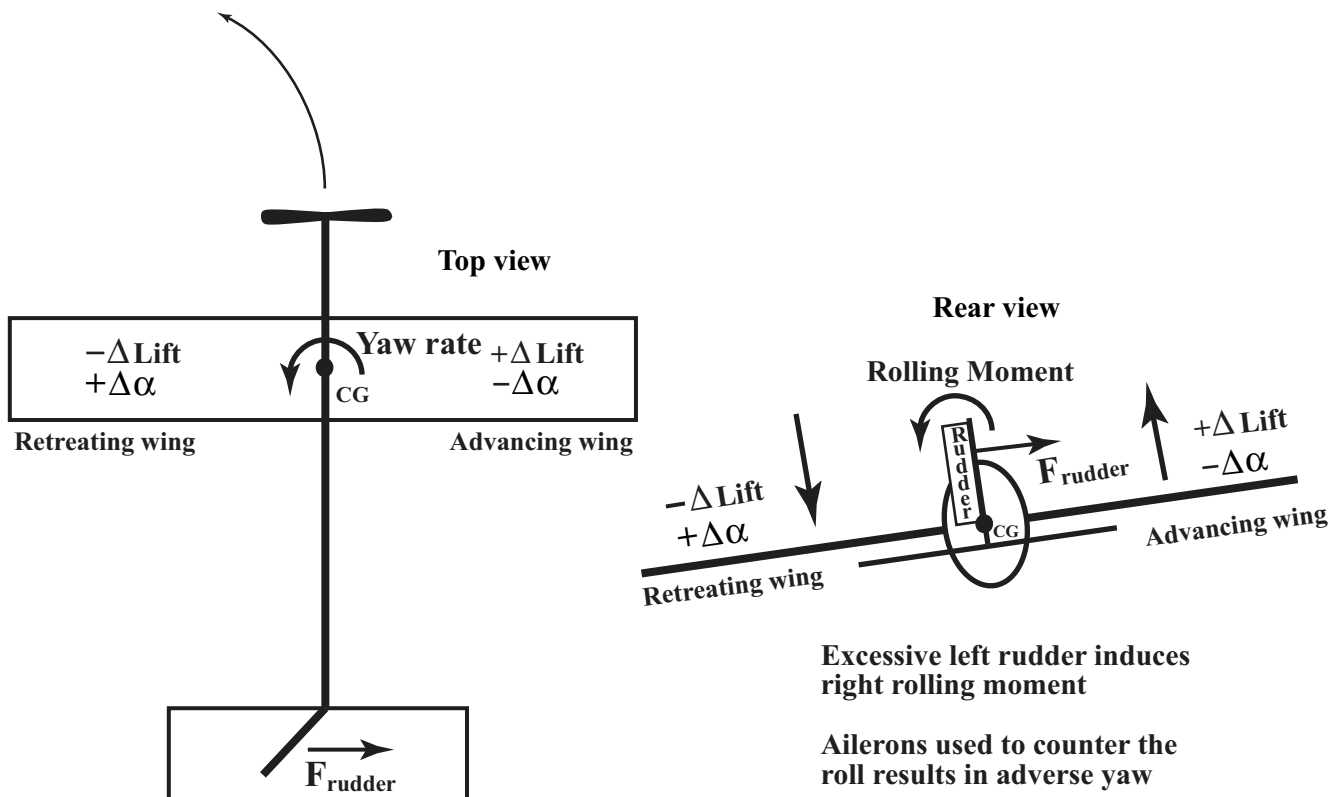
Typically the base-to-final stall spin occurs when a pilot overshoots the runway centerline and attempts to realign the aircraft by increasing bank angle to steepen the turn, adding aft stick and using bottom rudder i.e., in the direction of the turn. Increasing the bank angle and adding aft stick places the aircraft at a near critical/stall angle of attack. Adding bottom rudder results in a yaw rate that increases the angle of attack of the receding wing above the stall angle of attack while decreasing the angle of attack of the advancing wing. The receding wing stalls. The lift on the advancing wing increases resulting in a roll in the direction of the receding wing that results in an incipient inverted or near inverted spin that is unrecoverable and unsurvivable. The anatomy of a base-to-final spin is illustrated in Fig. 1.

Figure 1 also illustrates some second order effects that exacerbate the situation. For example, when the rudder is deflected the resulting rudder force, which typically acts above the vertical center of gravity, results in a rolling moment counter to the bank angle. The pilot may then add opposite aileron to counteract the rudder induced rolling moment. The aircraft is now cross-controlled. The down aileron on the advancing wing results in adverse yaw, causing the pilot to add additional rudder and yawing rate. The deflection of the rudder also results, again acting above the vertical center of gravity, in a nose up pitching moment which increases the angle of attack of the wing. And so it continues.

Figure 1. Anatomy of a base-to-final stall-spin.

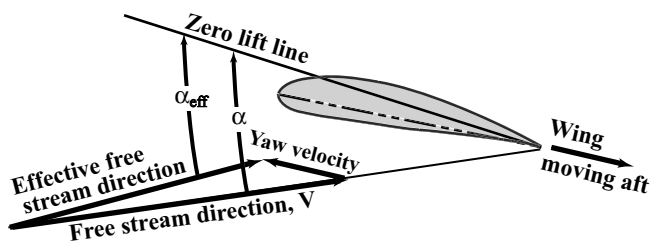
The velocity vector on the receding wing that results from yaw rate is in a direction that is opposed to the free stream velocity as shown in Fig. 2. In effect, the “wind” direction of the receding wing is trailing edge to leading edge. Given that the aircraft rotates about the center of gravity, the magnitude of the velocity resulting from yaw rate varies with distance from the center of gravity. Hence, the change in effective angle of attack varies with location along the wing.

Vectorally adding the freestream and yaw rate vectors, as shown in Fig. 2, results in an increase in the effective angle of attack on the receding wing compared to the absolute angle of attack when there is no yaw rate, i.e.,  $\alpha_{\text{eff}} > \alpha$ . If the aircraft is close to stall, the increase in effective angle of attack is enough to stall the receding wing.

Figure 2. The effect of yaw rate on angle of attack.

Similarly, but not shown in Fig. 2, the yaw rate associated with the advancing wing decreases the effective angle of attack and prevents the advancing wing from stalling. The result is an imbalance in lift on the receding and advancing wings which generates a rolling moment in the direction of the receding wing.

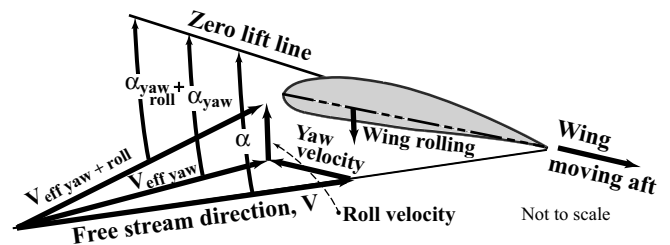
Because, near stall, the aircraft is typically neutrally or slightly unstable in roll as well as a result of the unbalanced wing lift, the aircraft rolls rapidly toward the stalled receding wing. The resulting roll rate further increases the receding wing effective absolute angle of attack as illustrated in Fig. 3.

Figure 3. The effect of yaw and roll rate on angle of attack.

Again, but not shown in Fig. 3, the roll rate on the advancing wing decreases the absolute angle of attack and prevents the advancing wing from stalling. Roll damping is also somewhat increased.
